# **EXHIBIT 7**

## Environmental Plans & Specifications

**Subject: Summary of Existing Site Conditions**

Application for Exemption to Construct on a Historic Fill Site  
Hartland Quarry Apartments  
644, 700 & 701 West Capitol Drive, Hartland, Wisconsin  
BRRTS #: 02-68-118316, 03-68-001111, 03-68-205411 / FID#: 268315630, 268554330

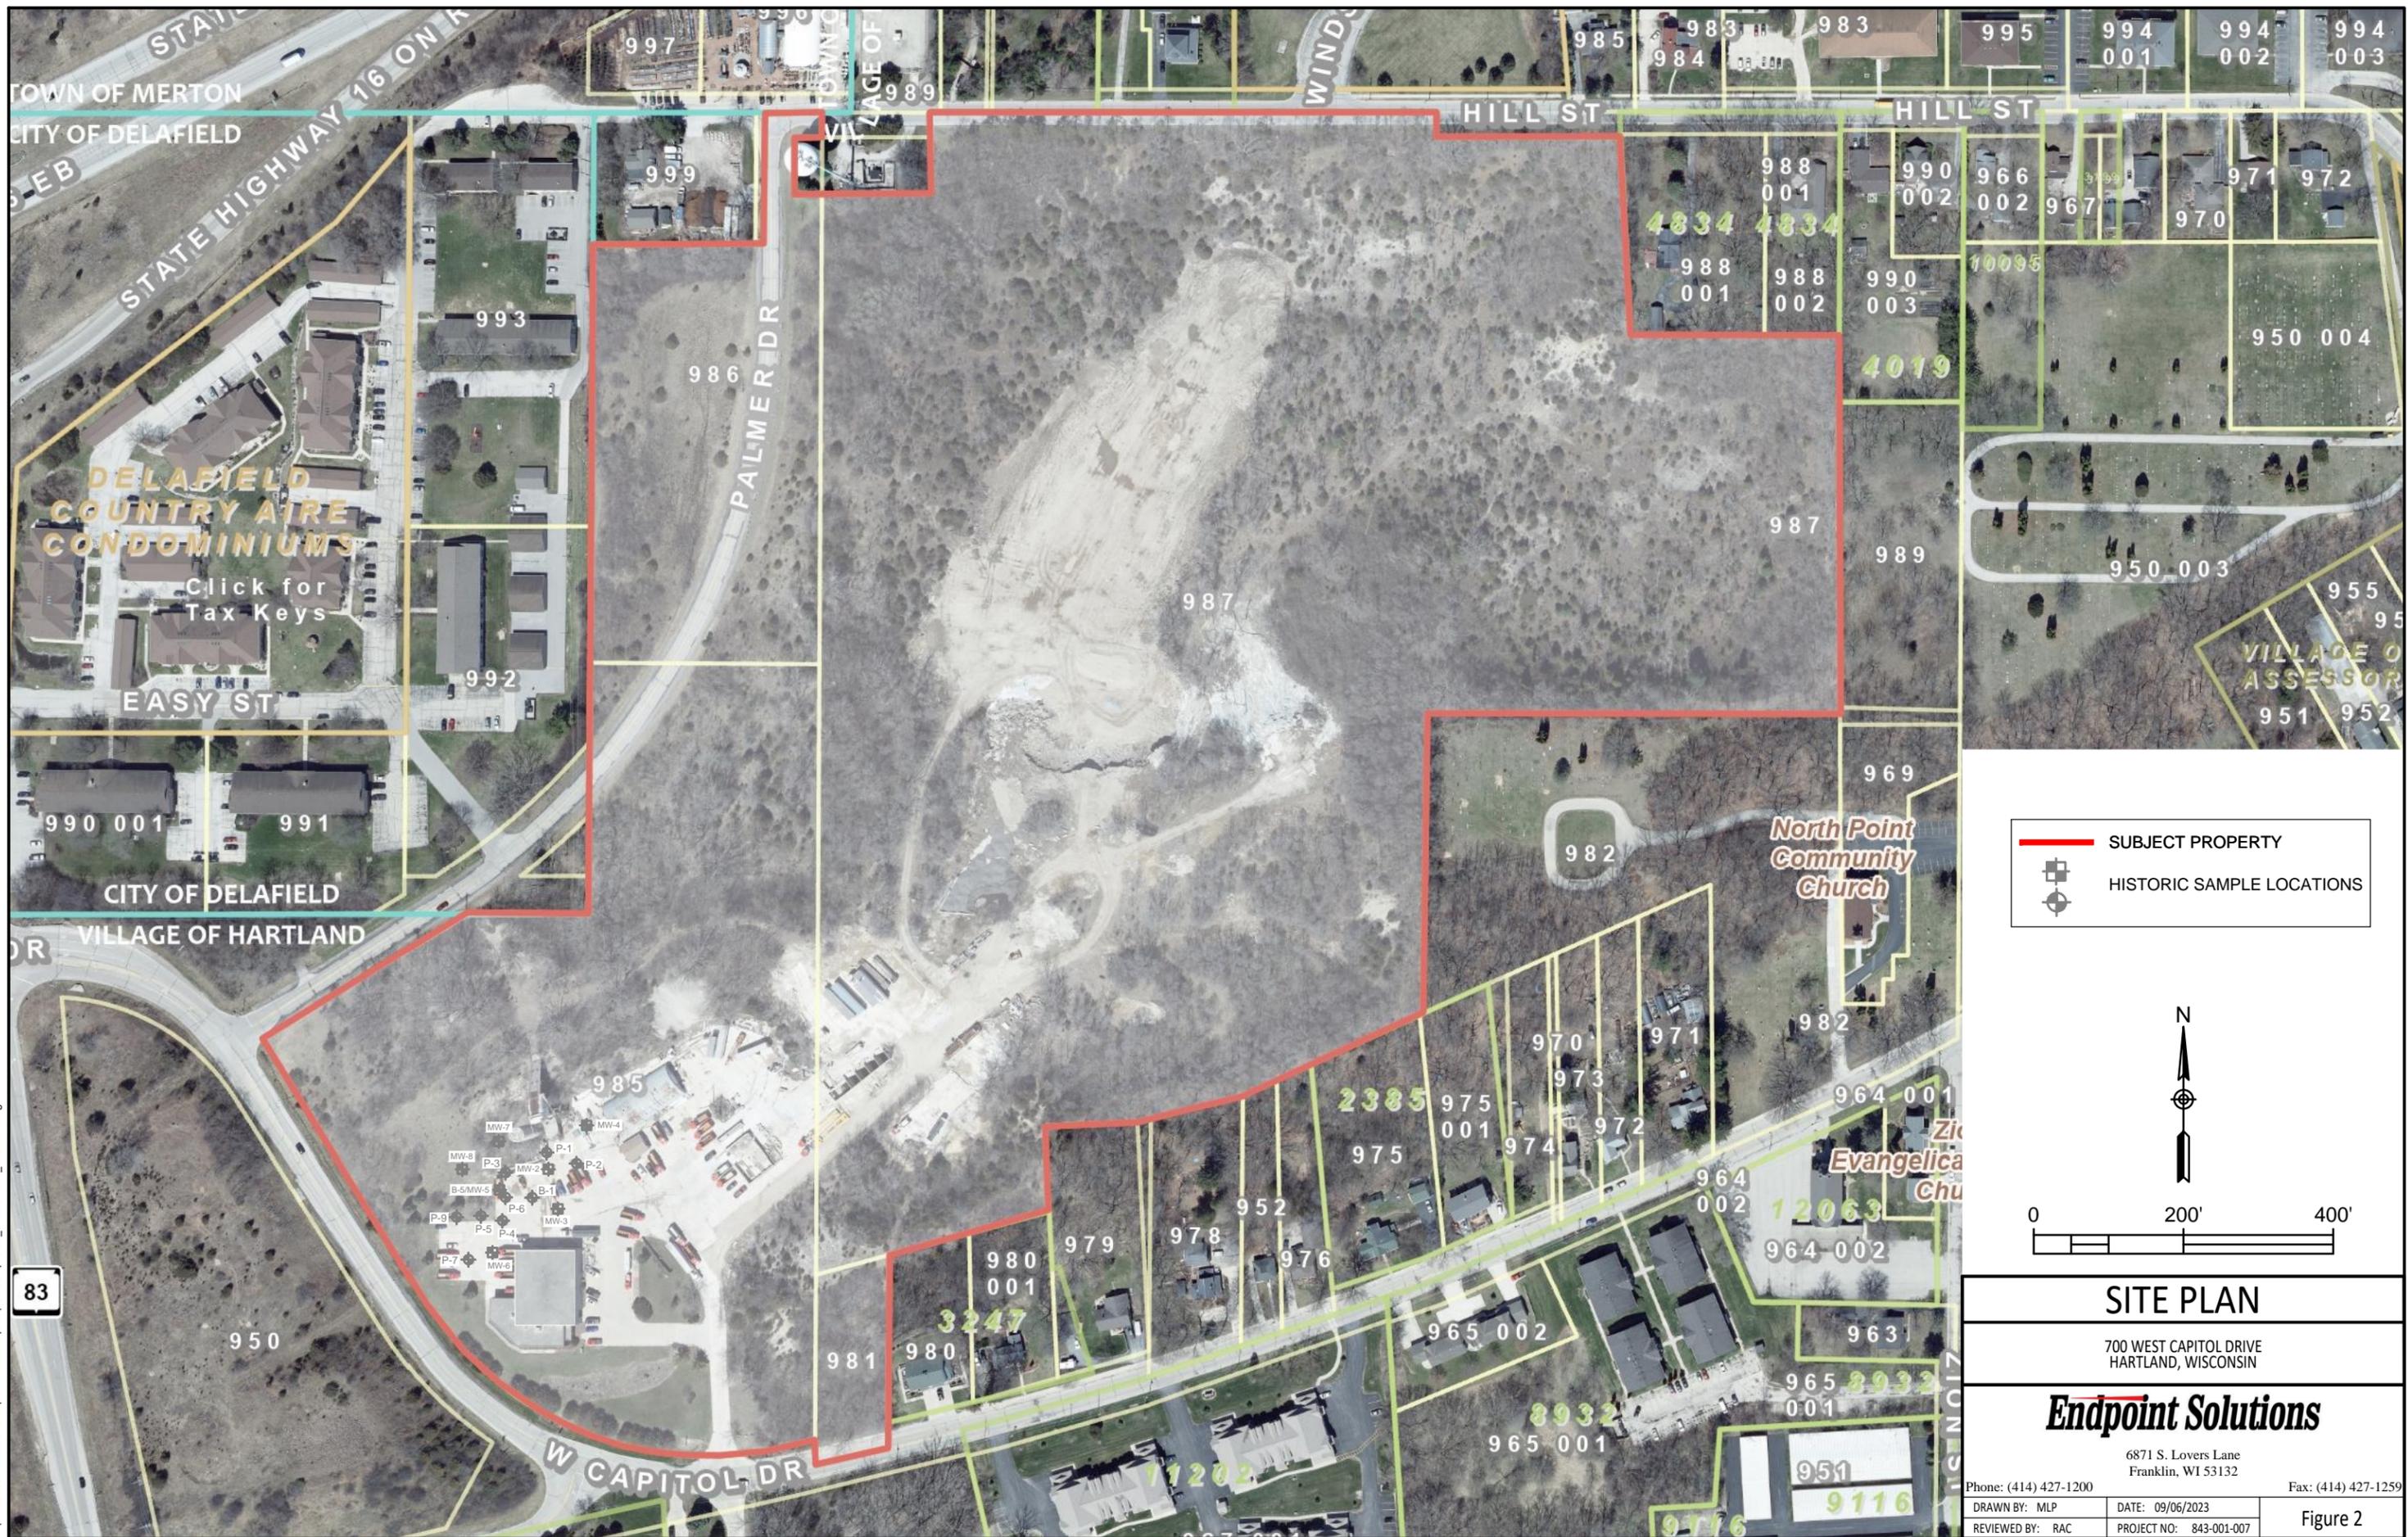
**Endpoint Solutions**  
 6871 S. Lovers Lane  
 Franklin, WI 53132  
 Phone: (414) 427-1200      Fax: (414) 427-1259  
 DRAWN BY: MLP      DATE: 09/06/2023  
 REVIEWED BY: RAC      PROJECT NO: 843-001-007      Figure 2

This information is being presented in support of an *Application for Exemption to Construct on a Historic Fill Site (Application for Exemption)* for the property located at 644, 700 & 701 West Capitol Drive, in the Village of Hartland, Waukesha County, Wisconsin (the "Site" or "subject property"), as depicted on the attached **Figure 1**. The bounds of the Site are depicted on **Figure 2**.

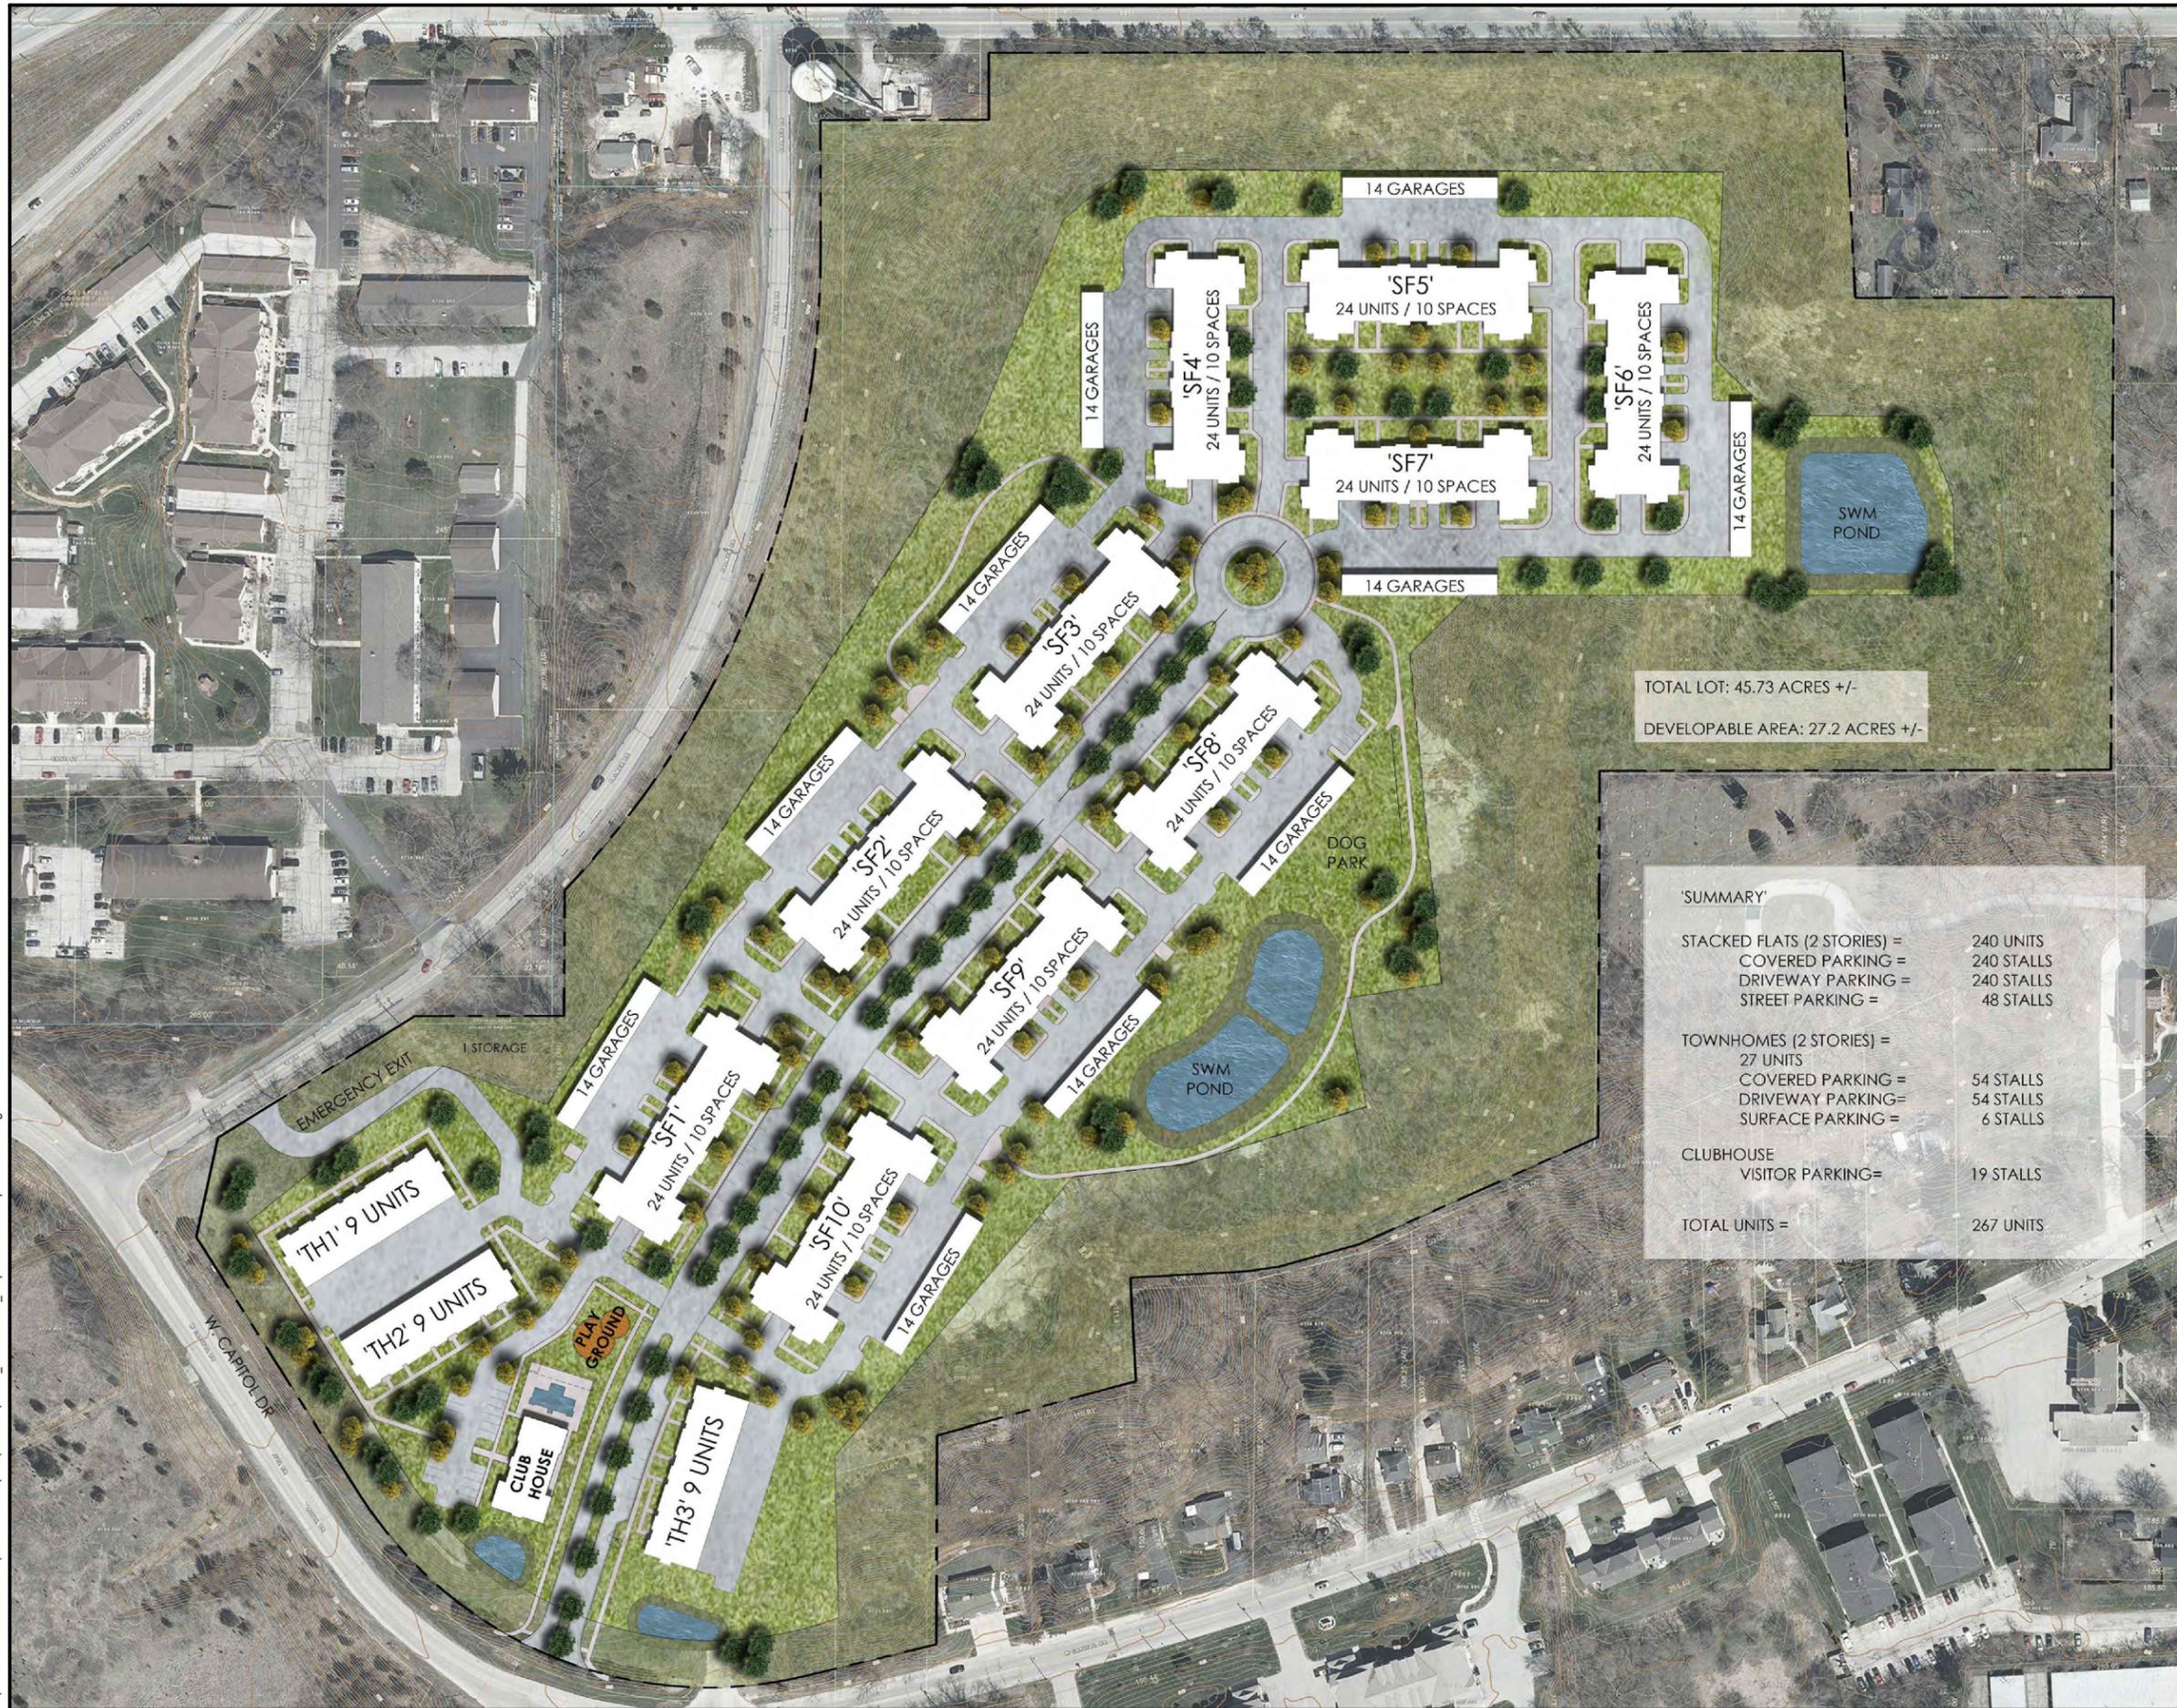
P:\Three Leaf Partners - 843\001 - Hartland\CAD\001-007\FIG 07\_843-001-007\_Proposed Redevelopment Plan.dwg

TOTAL LOT: 45.73 ACRES +/-  
 DEVELOPABLE AREA: 27.2 ACRES +/-

SUMMARY	
STACKED FLATS (2 STORIES) =	240 UNITS
COVERED PARKING =	240 STALLS
DRIVEWAY PARKING =	240 STALLS
STREET PARKING =	48 STALLS
TOWNHOMES (2 STORIES) =	27 UNITS
COVERED PARKING =	54 STALLS
DRIVEWAY PARKING =	54 STALLS
SURFACE PARKING =	6 STALLS
CLUBHOUSE VISITOR PARKING =	19 STALLS
<b>TOTAL UNITS =</b>	<b>267 UNITS</b>

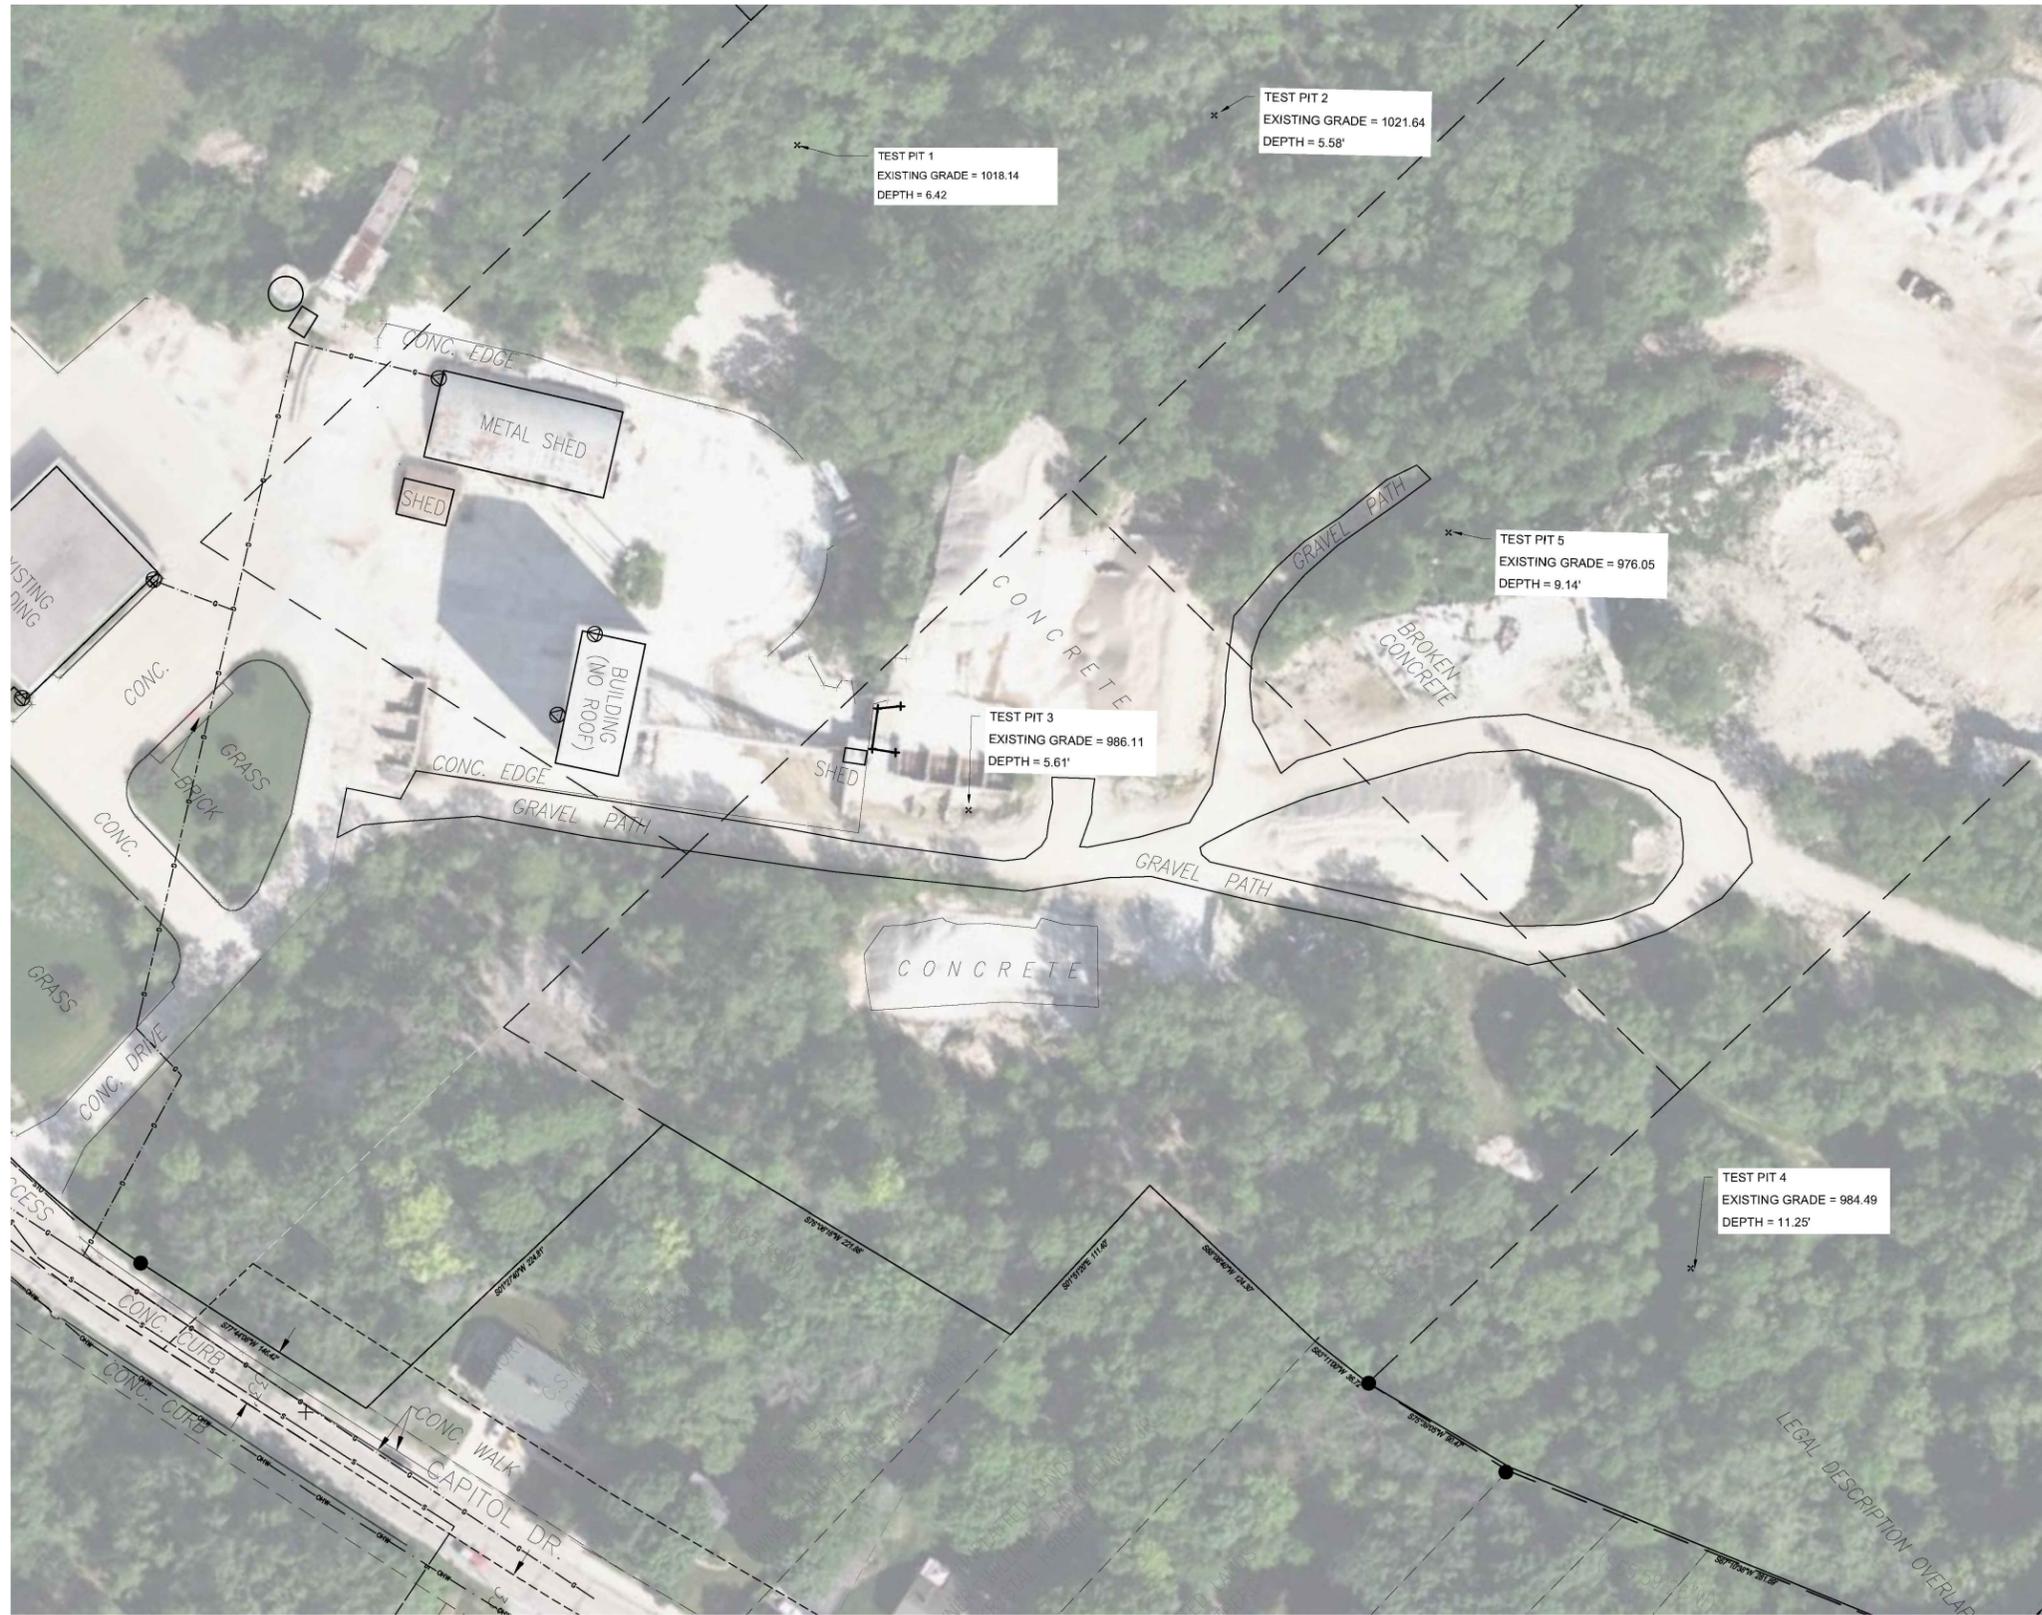
Figure 9

### SOUTH TEST PIT LOCATIONS

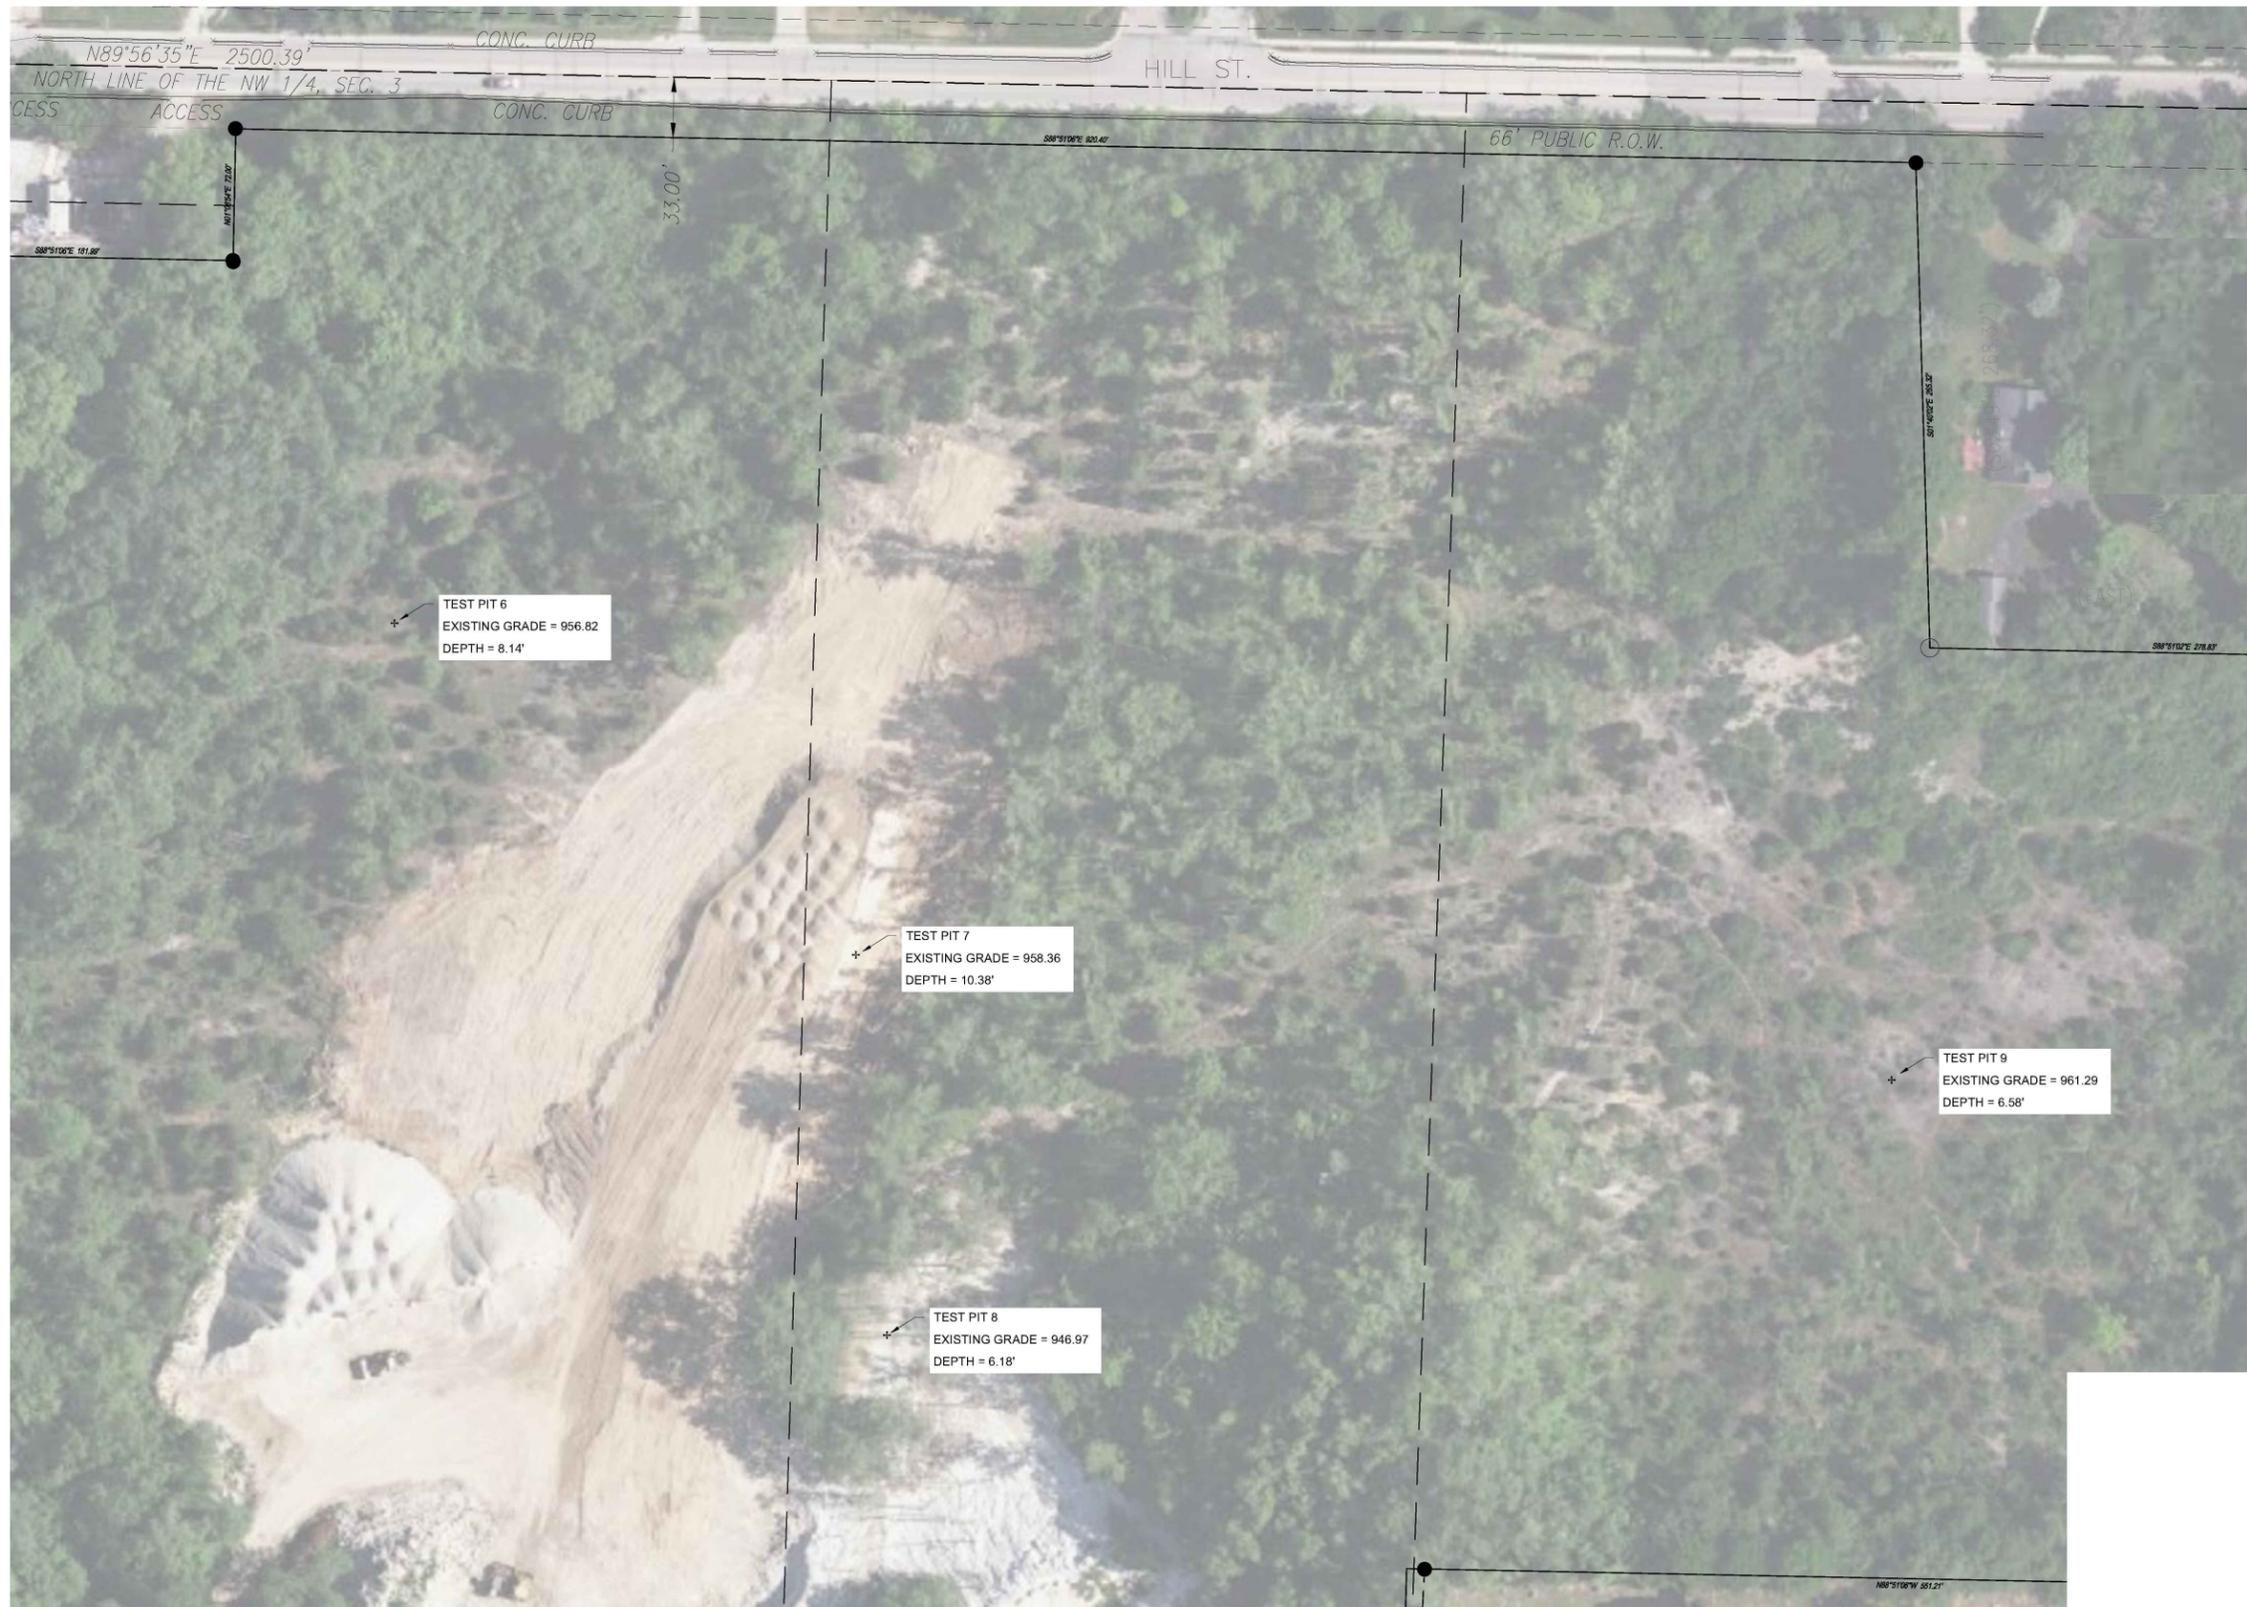
Figure 10

TEST PIT 6  
 EXISTING GRADE = 956.82  
 DEPTH = 8.14'

TEST PIT 7  
 EXISTING GRADE = 958.36  
 DEPTH = 10.38'

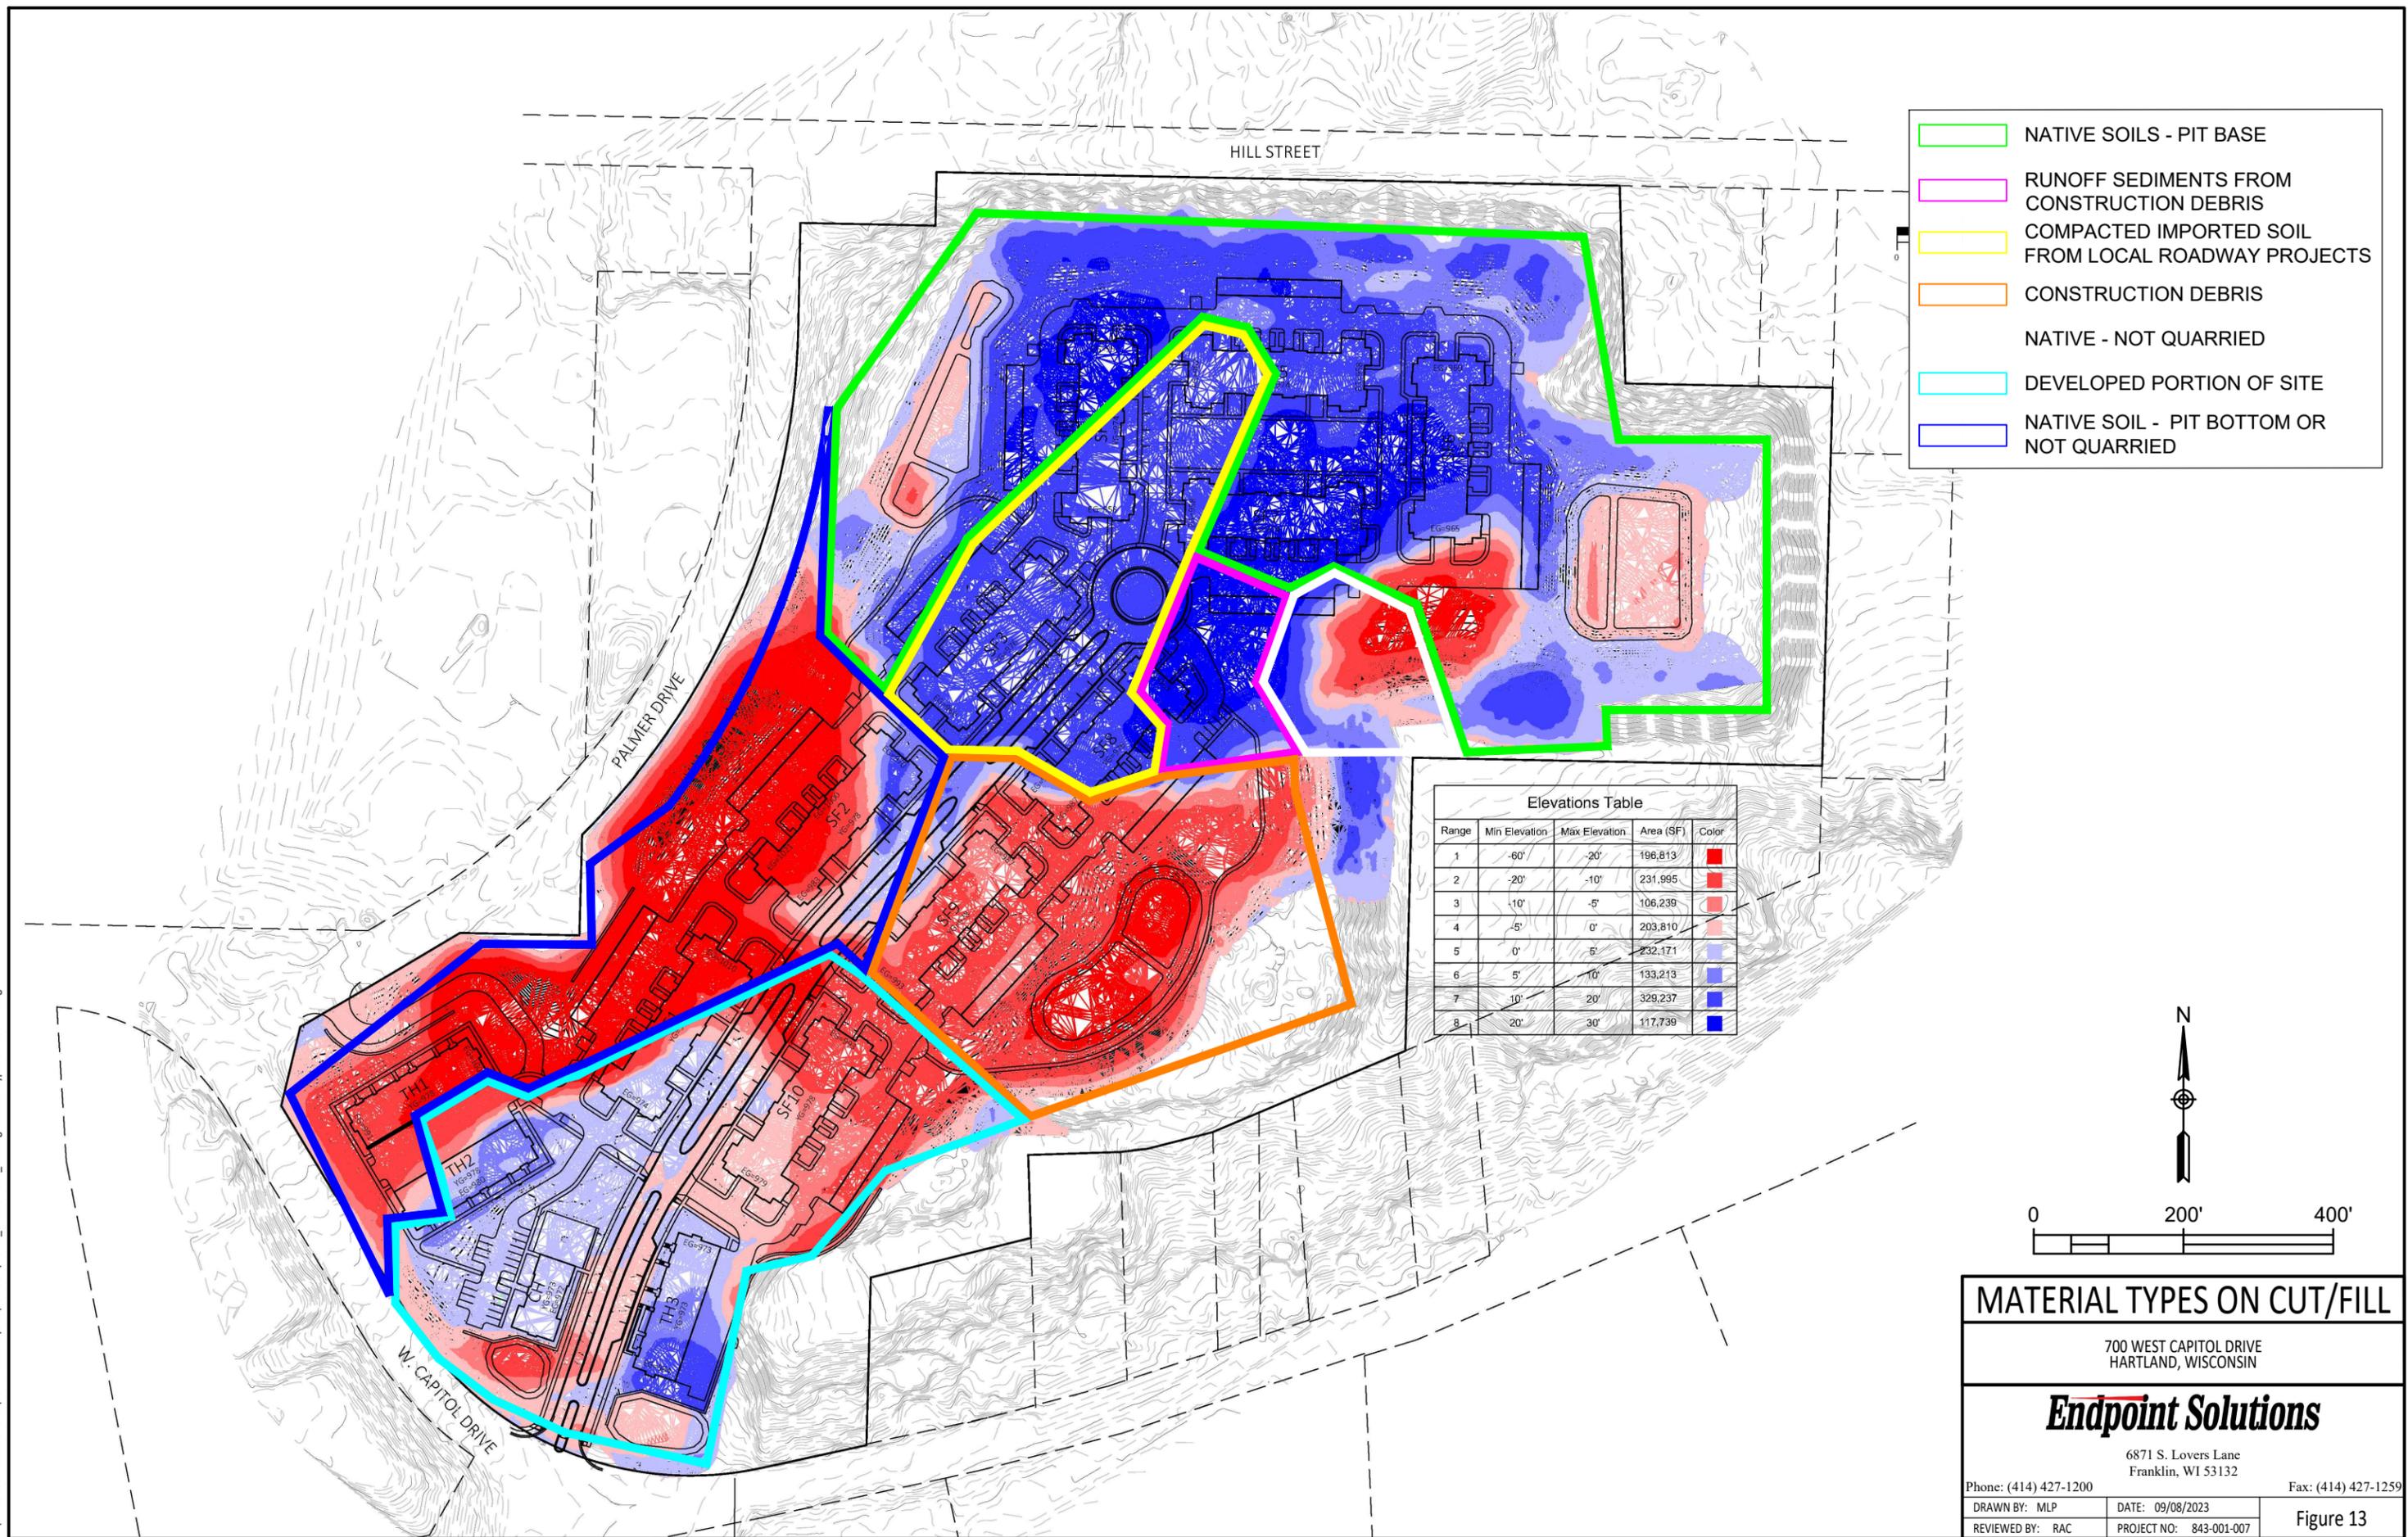
- NATIVE SOILS - PIT BASE
- RUNOFF SEDIMENTS FROM CONSTRUCTION DEBRIS
- COMPACTED IMPORTED SOIL FROM LOCAL ROADWAY PROJECTS
- CONSTRUCTION DEBRIS
- NATIVE - NOT QUARRIED
- DEVELOPED PORTION OF SITE
- NATIVE SOIL - PIT BOTTOM OR NOT QUARRIED

Range	Min Elevation	Max Elevation	Area (SF)	Color
1	-60'	-20'	196,813	Red
2	-20'	-10'	231,995	Red
3	-10'	-5'	106,239	Red
4	-5'	0'	203,810	Red
5	0'	5'	232,171	Light Blue
6	5'	10'	133,213	Blue
7	10'	20'	329,237	Blue
8	20'	30'	117,739	Blue

FIGURE 13 – EXISTING MATERIAL TYPES ON CUT-FILL PLAN

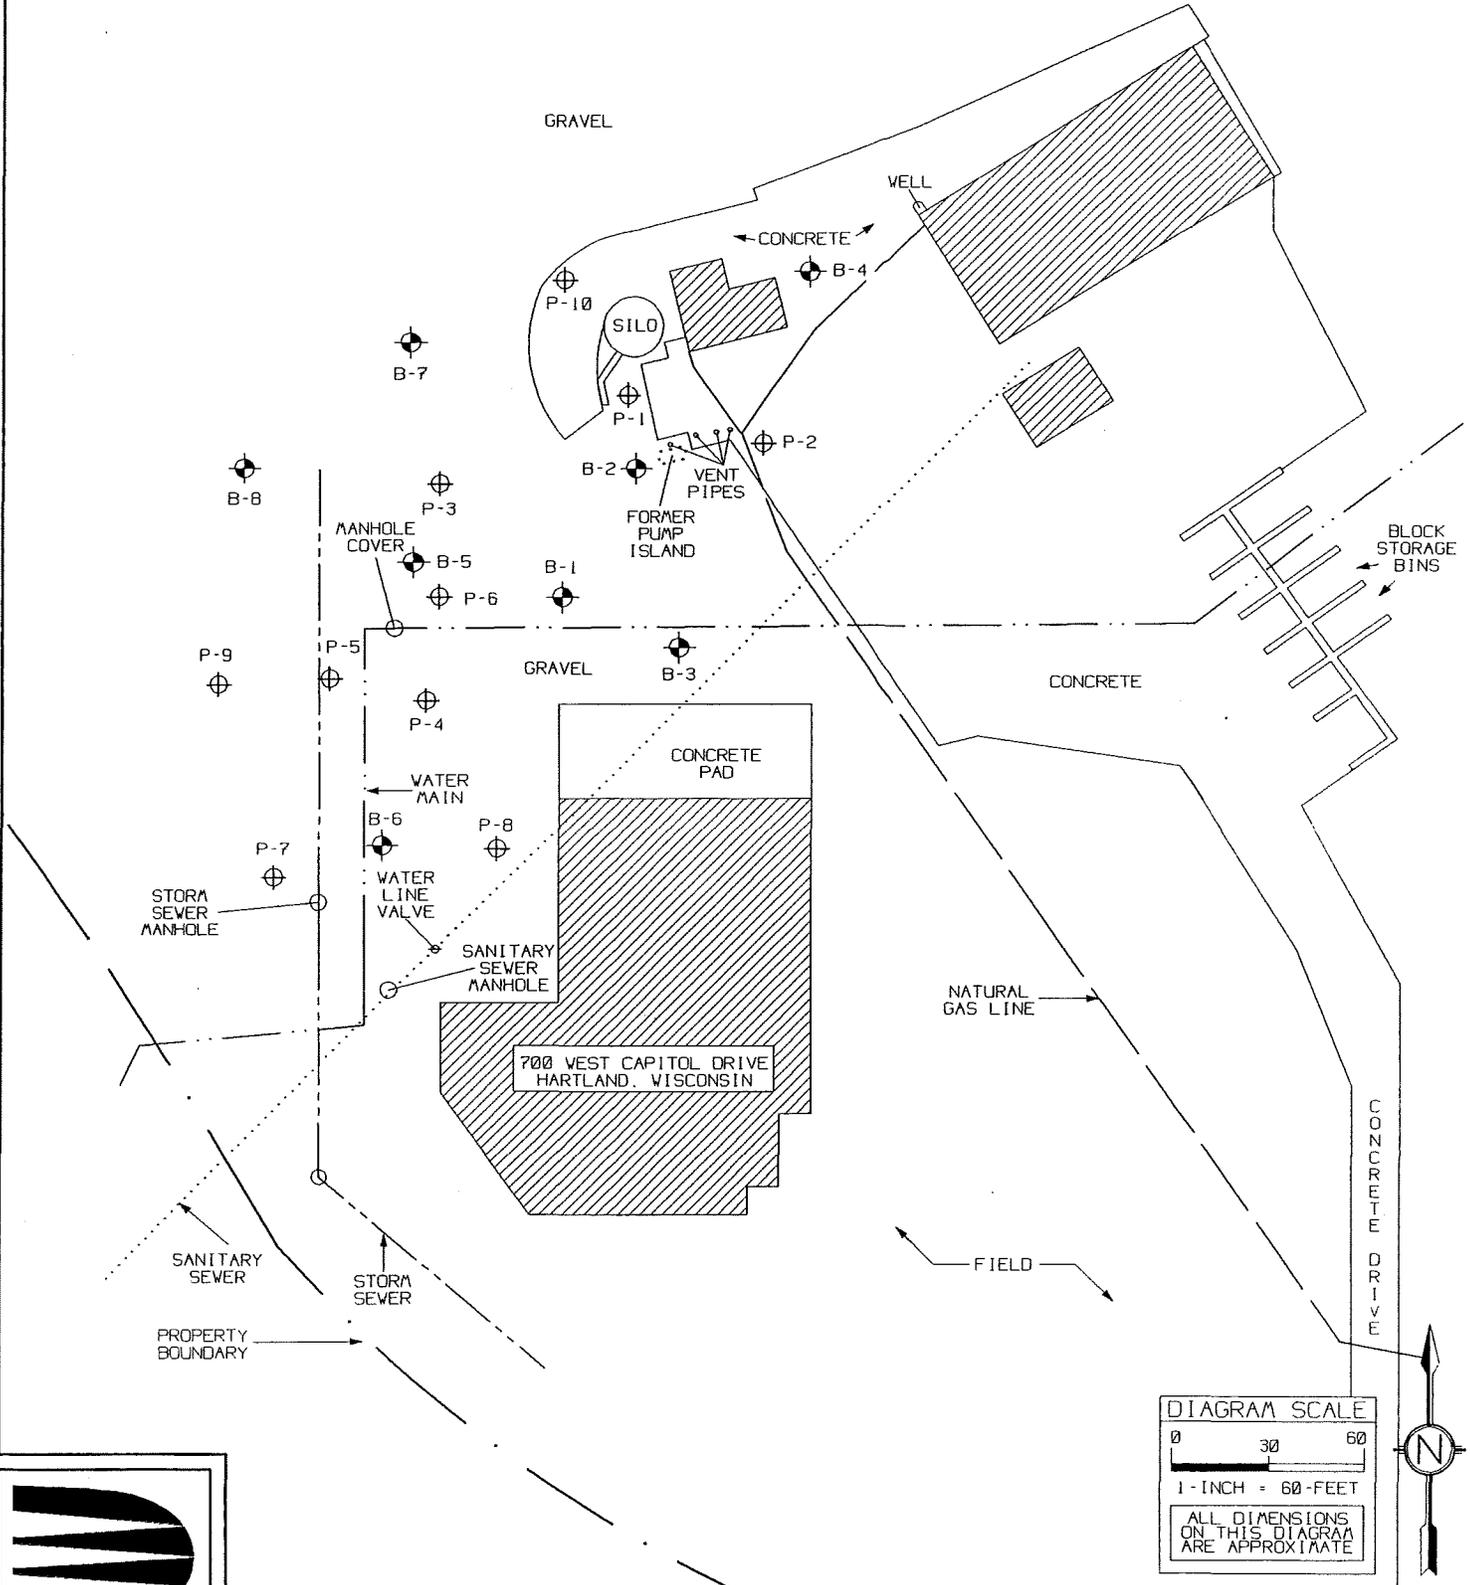
LAFARGE - HARTLAND REMEDIAL INVESTIGATION	PROJECT NO. J98109 PA DVF	PROBEHOLE AND BORING LOCATIONS DIAGRAM	FIGURE
	DRAWN BY JAM DATE: 07/30/99		4
	CHKD BY <i>DVF</i> DATE 7-21-99		
	APRVD BY <i>TLO</i> DATE 9-21-99

⊕ = PROBEHOLE LOCATION  
 ⊕ = BORING LOCATION
