# **EXHIBIT 7**

## Environmental Plans & Specifications

**Subject: Summary of Existing Site Conditions**

Application for Exemption to Construct on a Historic Fill Site  
Hartland Quarry Apartments  
644, 700 & 701 West Capitol Drive, Hartland, Wisconsin  
BRRTS #: 02-68-118316, 03-68-001111, 03-68-205411 / FID#: 268315630, 268554330

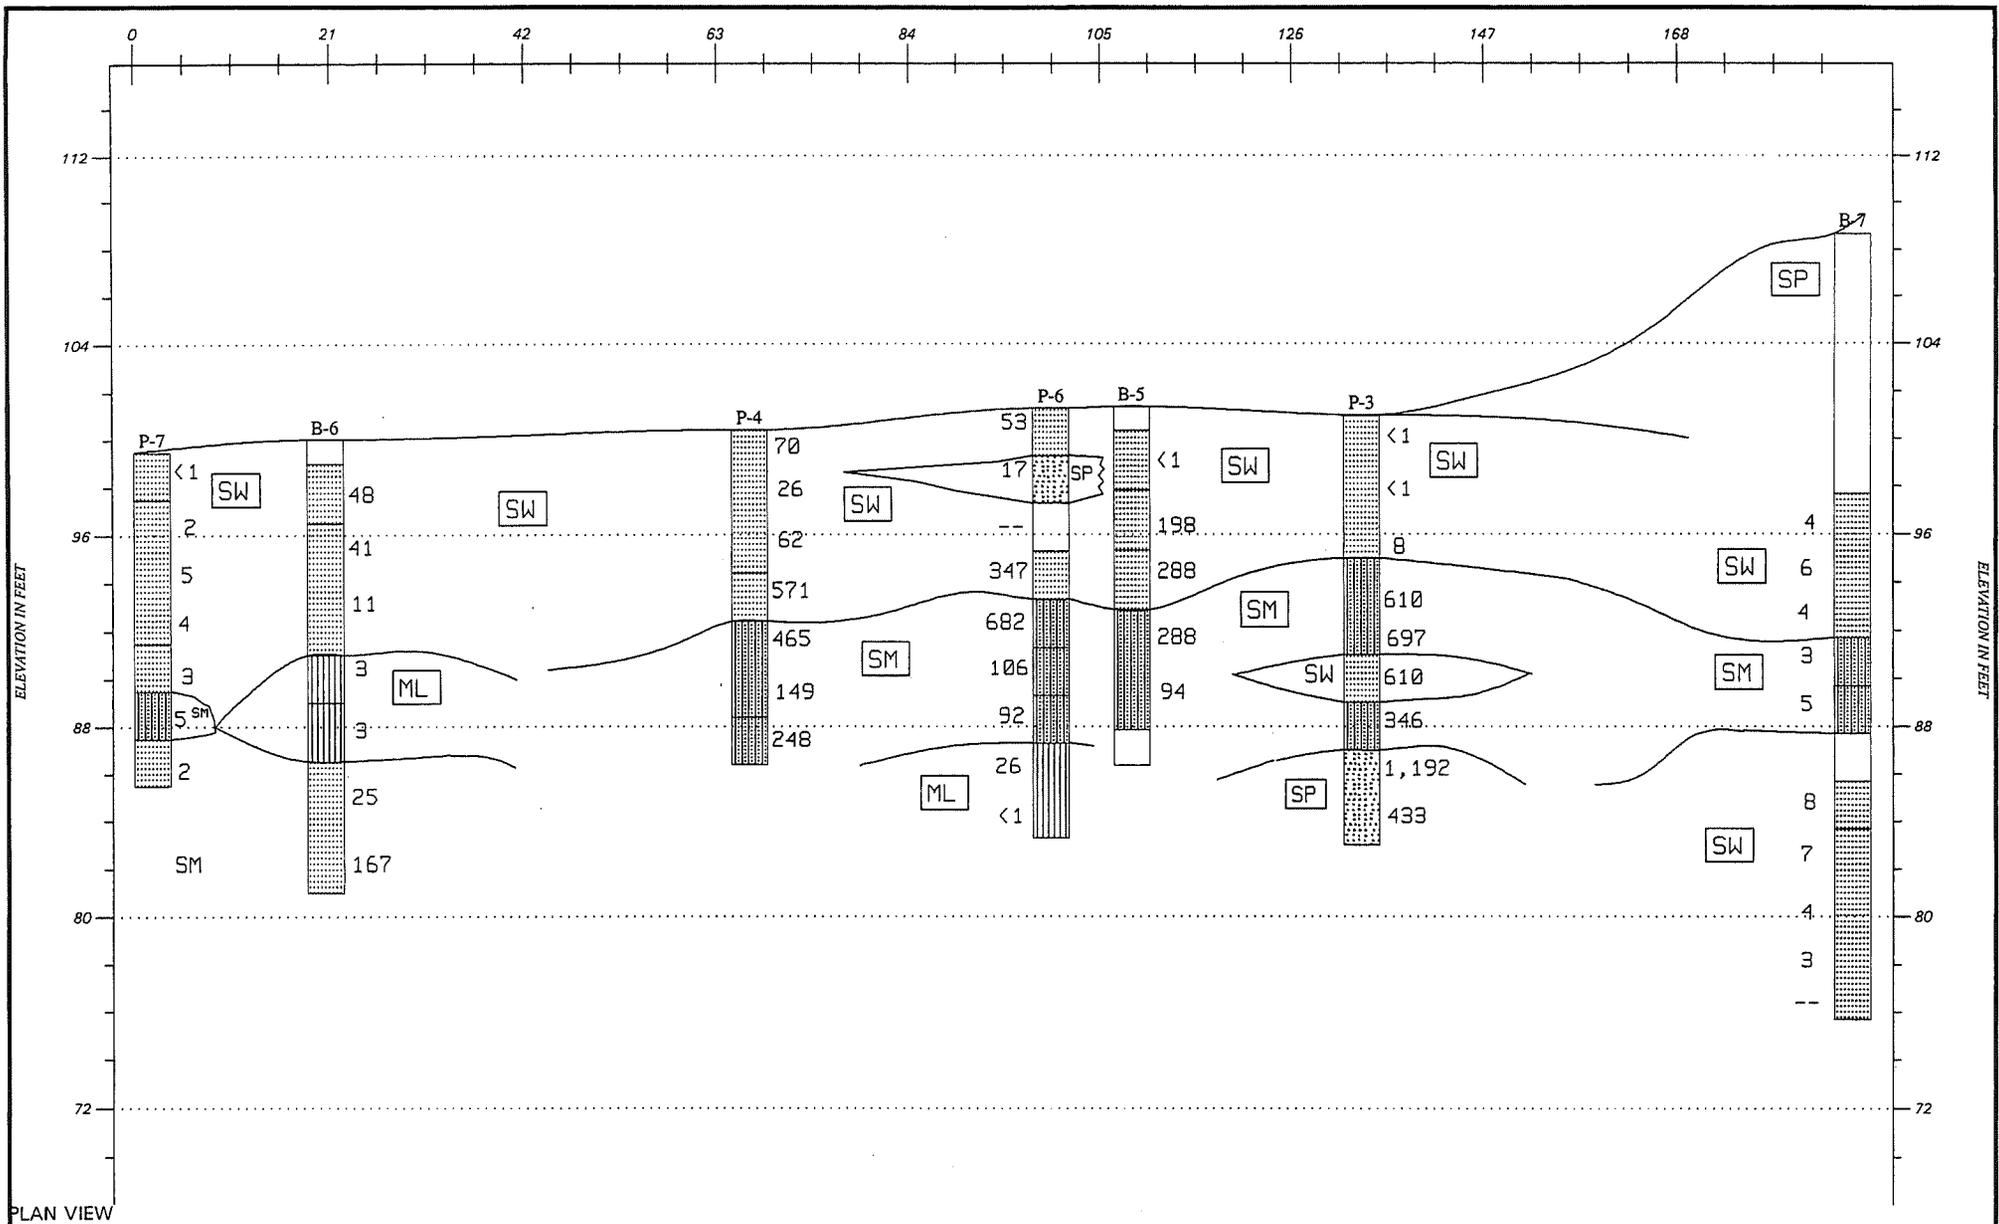
DRAKE ENVIRONMENTAL, INC.		
GEOLOGICAL CROSS SECTION		
HORIZONTAL SCALE: 1" = (proportional)	FIELD TECHNICIAN	DATE DRAWN
VERTICAL SCALE: 1" = 8'	TJO	8/23/1999
LAFARGE - HARTLAND		
PROJECT NUMBER: J98109		FIGURE NUMBER
		6

PLAN VIEW

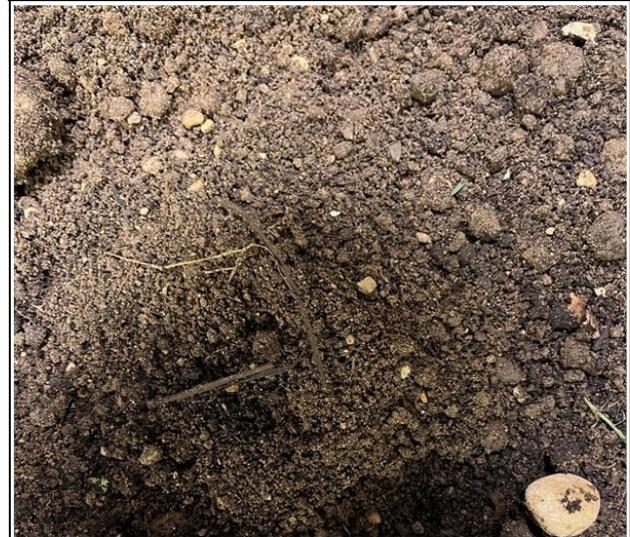
### Sample Photo

<b>Oversize Correction Needed:</b>	Yes	<b>Visual Description:</b>	Dark Brown Silty Clay with Organic
<b>Maximum Dry Density (lb/ft³):</b>	<b>123.9</b>	<b>Compaction Method Used:</b>	A (ASTM D1557)
<b>Optimum Moisture (%):</b>	<b>8.5</b>	<b>Type of Rammer Used:</b>	Manual
<b>Test Date:</b>	04/25/2023	<b>Sp. Gravity (Est):</b>	2.60
<b>Lab Technician:</b>	Abdel Deif

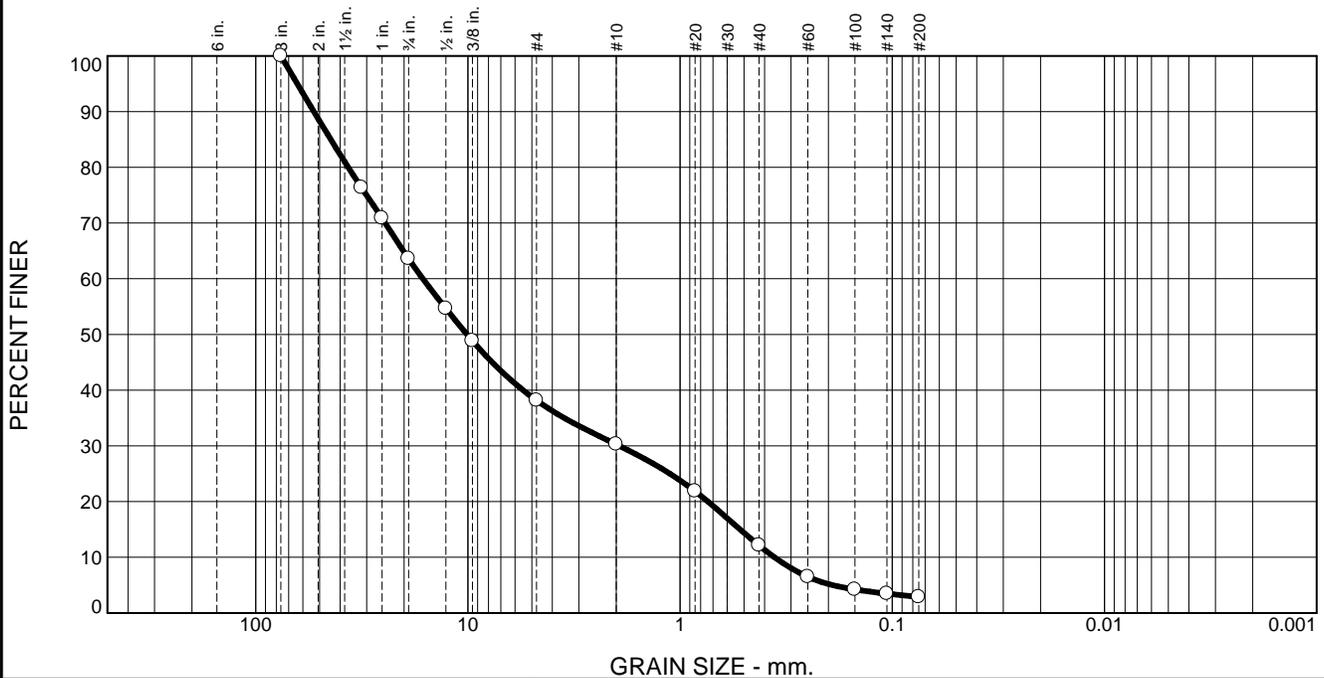
# Sieve Analysis Report

% +3"	% Gravel		% Sand			% Fines	
	Coarse	Fine	Coarse	Medium	Fine	Silt	Clay
0.0	36.4	25.4	7.9	18.2	9.2	2.9

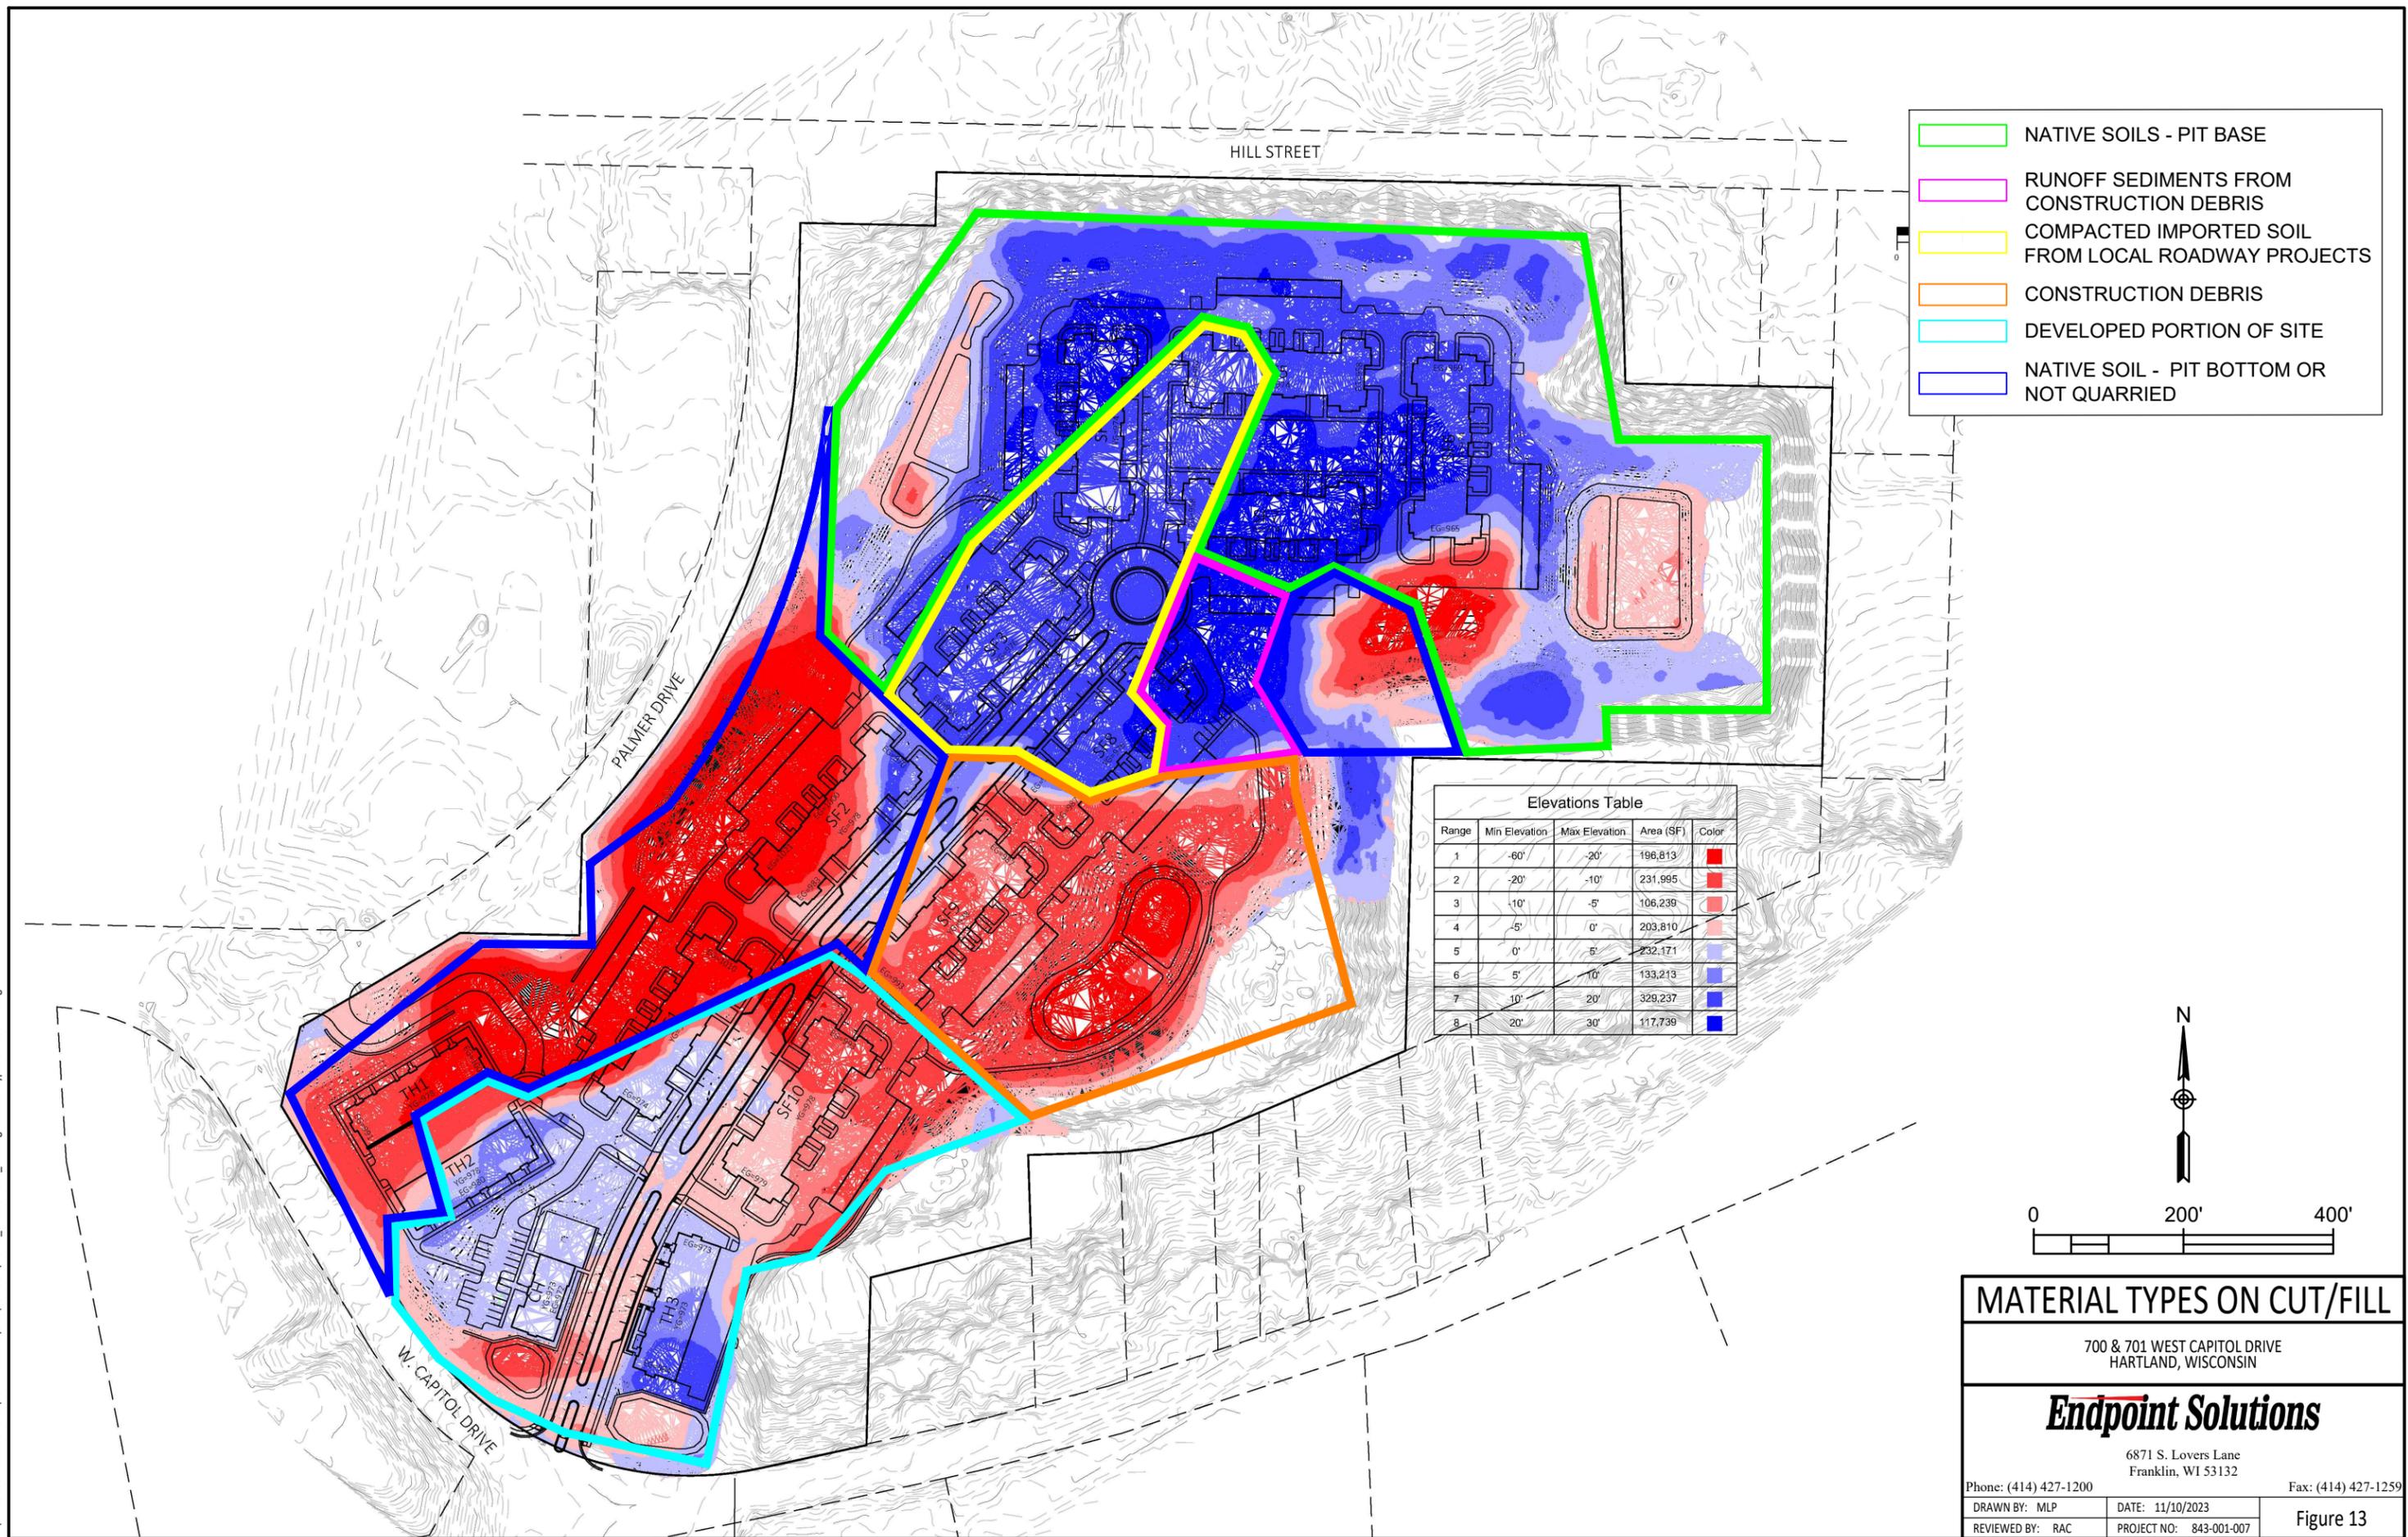
FIGURE 13 – MATERIAL TYPES ON CUT/FILL

- NATIVE SOILS - PIT BASE
- RUNOFF SEDIMENTS FROM CONSTRUCTION DEBRIS
- COMPACTED IMPORTED SOIL FROM LOCAL ROADWAY PROJECTS
- CONSTRUCTION DEBRIS
- DEVELOPED PORTION OF SITE
- NATIVE SOIL - PIT BOTTOM OR NOT QUARRIED

Range	Min Elevation	Max Elevation	Area (SF)	Color
1	-60'	-20'	196,813	Red
2	-20'	-10'	231,995	Red
3	-10'	-5'	106,239	Red
4	-5'	0'	203,810	Red
5	0'	5'	232,171	Blue
6	5'	10'	133,213	Blue
7	10'	20'	329,237	Blue
8	20'	30'	117,739	Blue

These six (6) general areas are depicted on **Figure 13** and include:

Based on **Figure 13**, the majority of the cuts will occur within the dark blue outlined unquarried native sand and gravel sidewalls, the orange outlined area of construction debris consisting of concrete slabs and the northern portion of the light blue outlined concrete covered developed portion of the Site. The isolated cut areas in the northern portion of the Site are located in areas of native undisturbed sand and gravel associated with either unquarried areas or the base of the quarry.

As depicted on **Figure 8**, the majority of fills will occur in the northern portion of the Site, with fill depths approaching 30-feet in some areas. Minor areas of fill are located in the southern portion of the Site in the vicinity of the following proposed buildings: Townhouse 2 (TH2), Townhouse 3 (TH3) and the Club House (CH). With the exception of the area of compacted imported fill from local utility projects (outlined in yellow on **Figure 13**) and a small area of runoff sedimentation (outlined in pink on **Figure 13**), fill materials will be placed on the native undisturbed sand and gravel quarry base.

We propose to collect and analyze the additional samples discussed above prior to initiating the soil processing. We propose to collect a maximum of 50 samples located throughout the areas identified as Compacted Impacted Soils and Runoff Sediments on **Figure 13**. The sample points will be located on an approximately 60-ft grid spacing. Based on existing sampling and survey data, we estimate the Compacted Imported Soils and Runoff Sediments to average approximately five (5) ft thick. We propose to collect a create a composite sample at each location to be submitted for laboratory analysis for PAHs and the RCRA metals. We understand this data will be utilized to manage and document the placement locations of these soils; however, unless exceptional concentrations are detected, it is also our understanding that the results of this sampling will not affect the overall MMP described herein.

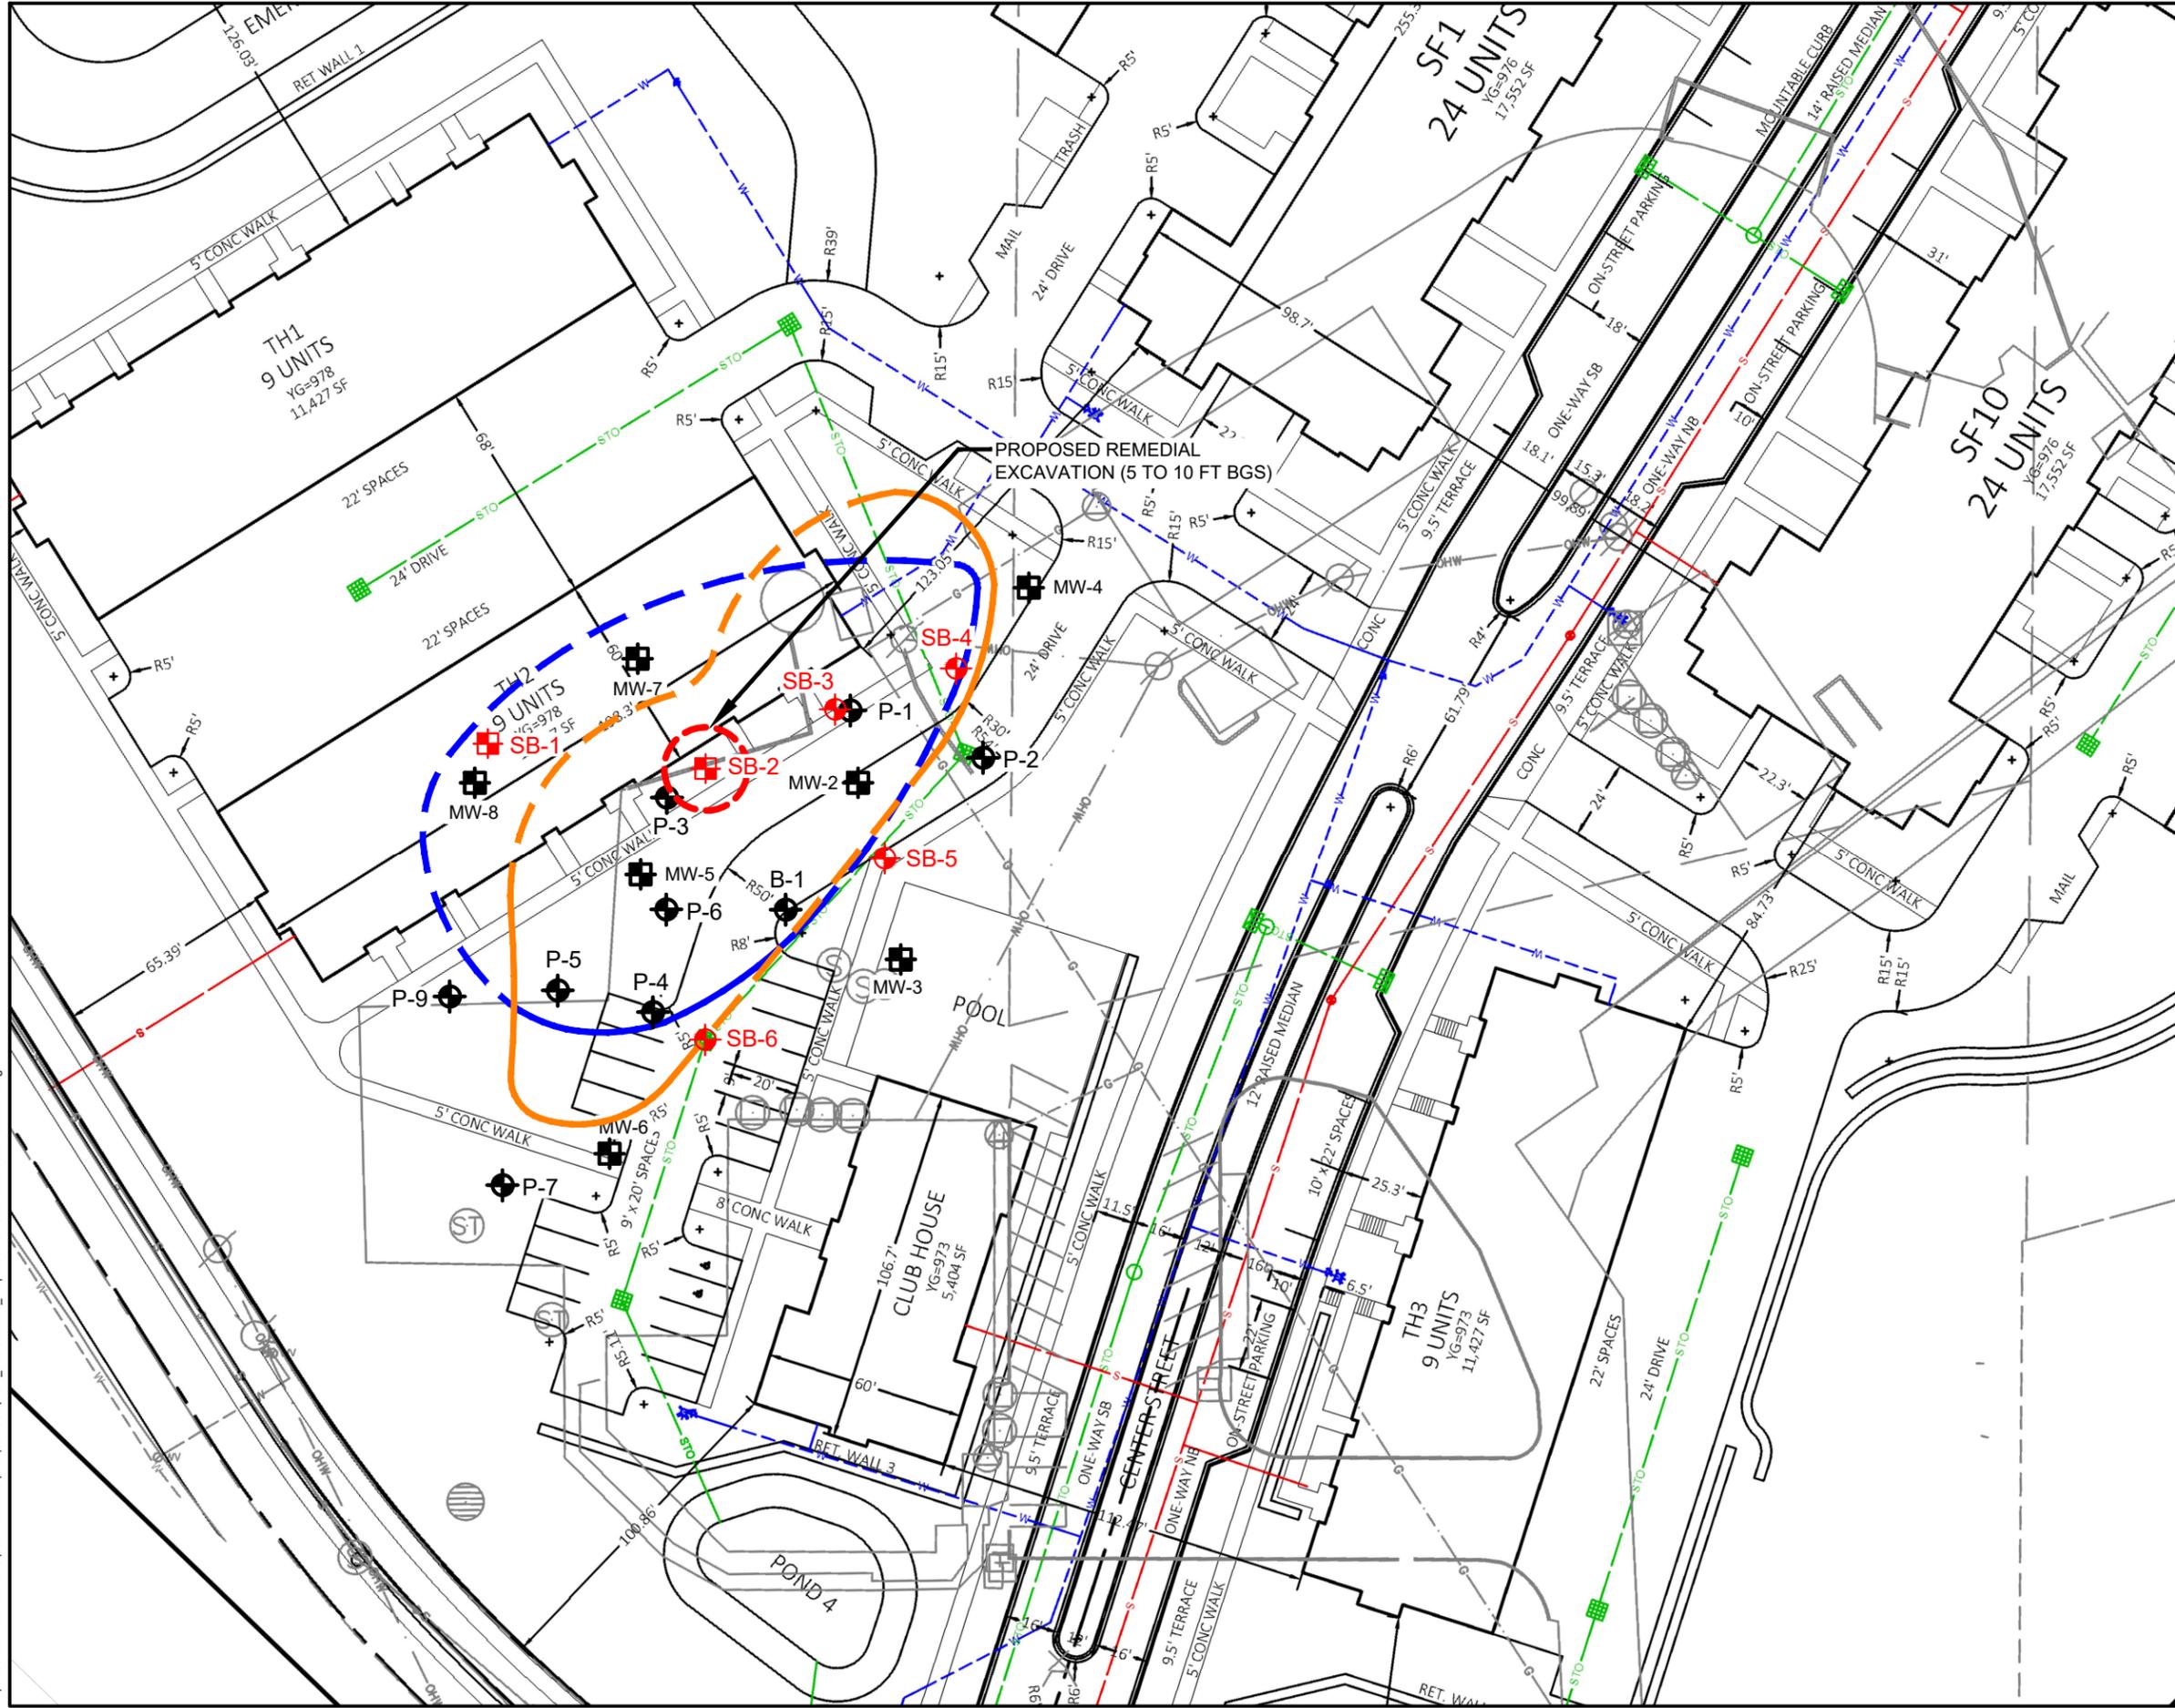
## PROPOSED REMEDIAL EXCAVATION LOCATION

APPROXIMATE EXTENT OF GROUNDWATER VOC PAL EXCEEDANCES (DASHED WHERE INFERRED)

VOC - VOLATILE ORGANIC COMPOUNDS  
 PAL - PREVENTATIVE ACTION LIMIT  
 DRO - DIESEL RANGE ORGANICS
